ZU1 SYSTEM BLOCK DIAGRAM

PROJECT : ZU1

Quanta Computer Inc.

Size	Document Number	Rev
	CLK_GEN/CK505	3B
Date:	Tuesday, April 10, 2007	Sheet 2 of 39

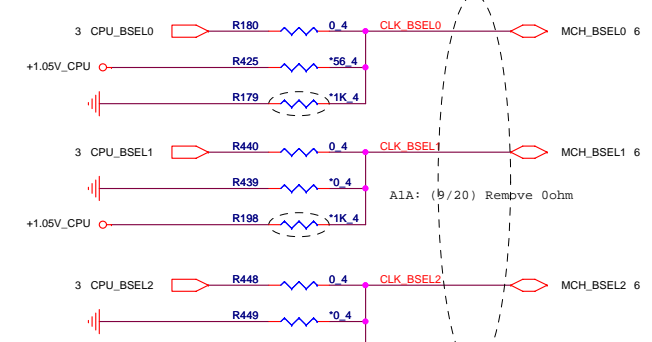
CPU Clock select

BSEL Frequency Select Table

FSC	FSB	FSA	Frequency
0	0	0	266Mhz
0	0	1	133Mhz
0	1	1	166Mhz
0	1	0	200Mhz
1	1	0	400Mhz
1	1	1	Reserved
1	0	1	100Mhz
1	0	0	333Mhz

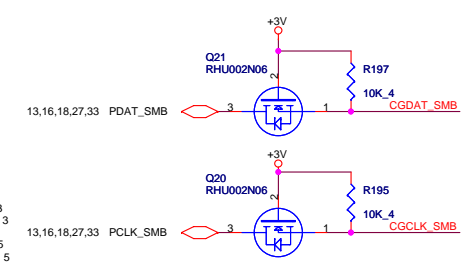
Clock Gen I2C

Pin	Active	Control signal
32	Low	SRC9/#9
33	Low	SRC10/#10

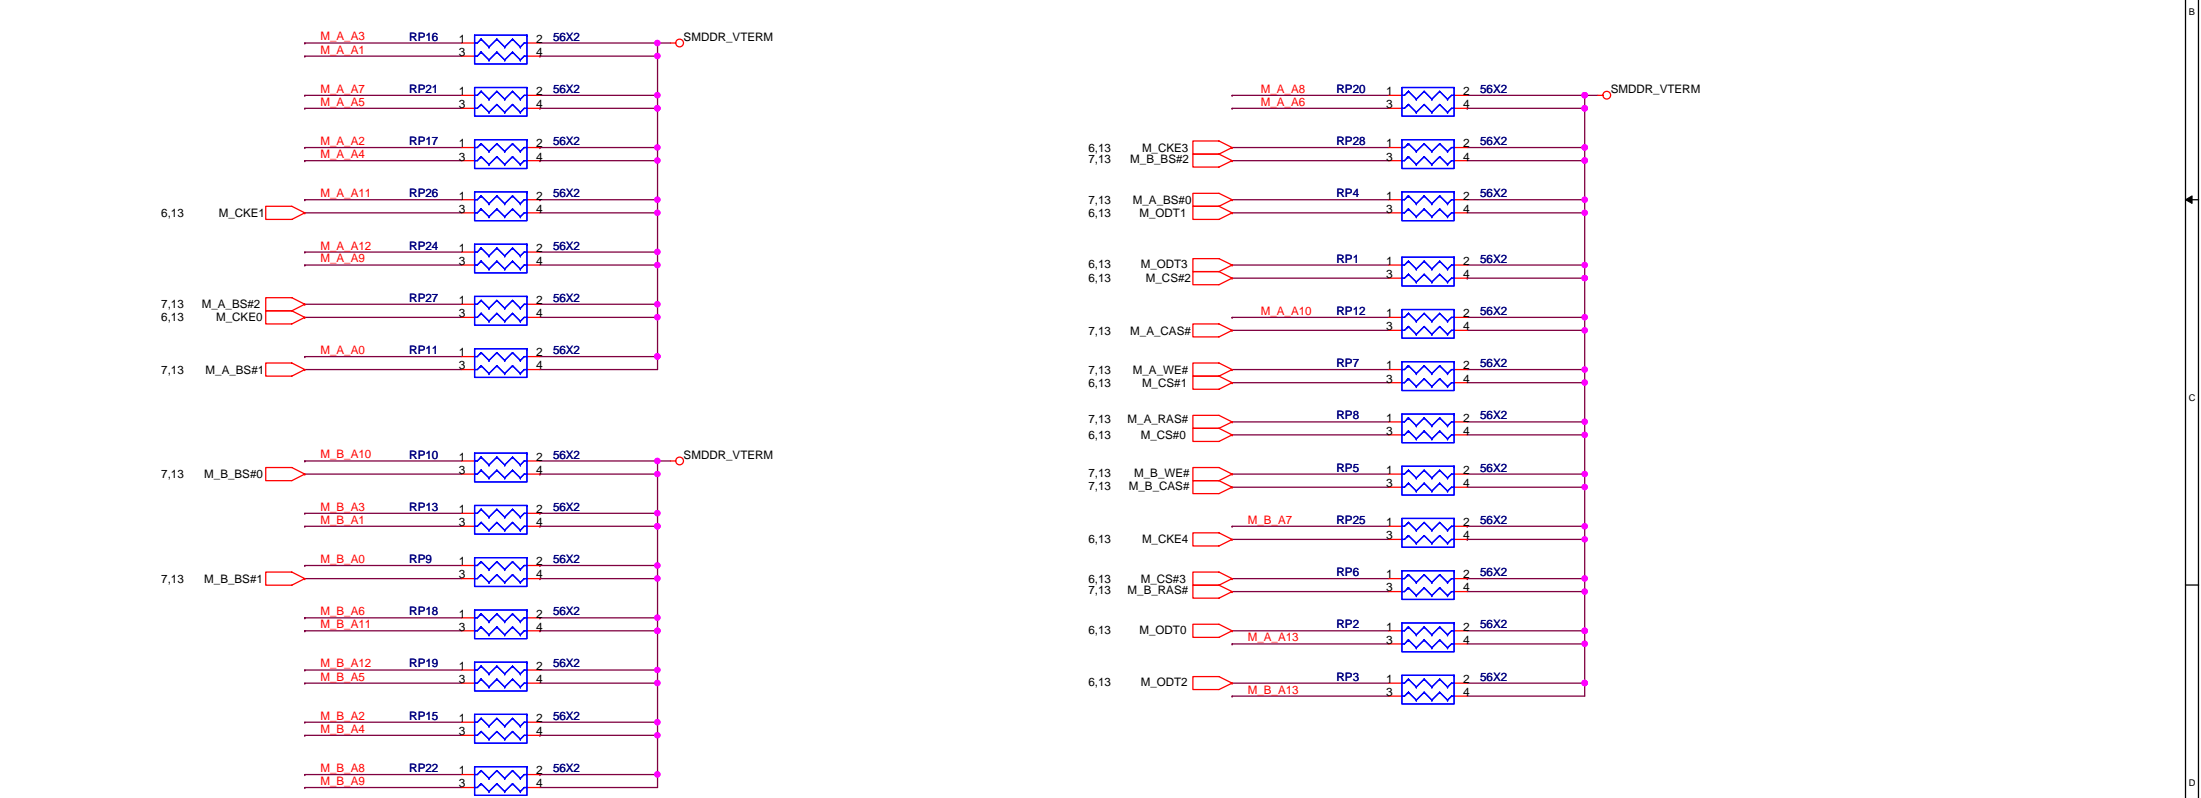
DDR2 Dual channel A/B PU

Place one cap close to every 2 pull-up resistor terminated to SMDDR_VTERM

INTEL FAE (08/17)
ADD MA14 FOR DUAL LAYERS RAM

6,13 M_A A14
6,13 M_B A14

R144 56.4
R135 56.4

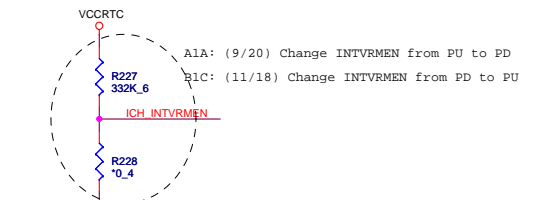
SB Strap

ICH8-M Internal VR Enable strap
(Internal VR for Vccsus1_05, VccSus1_5 and VccCL1_5)

INTVRMEN	Low = Internal VR disable High = Internal VR enable(Default)
----------	---

97	ICH8-M Strap issue	Change INTVRMEN from PD to PU	B1C	14		
98	Leakage issue	add D43,D44 to stop leakage from EC to SB	B1C	16		
99	ICH8-M issue	change DOCKIN# from GPIO7 to GPIO12	B1C	16		
100	Power sequence issue	short PWROK_EC to MPWROK	B1C	16		
101	ICH8-M issue	PU GPIO10 to +3V, PD GPIO14 to GND	B1C	16		
102	ICH8-M issue	remove R229,R233,C355	B1C	16		
<div>

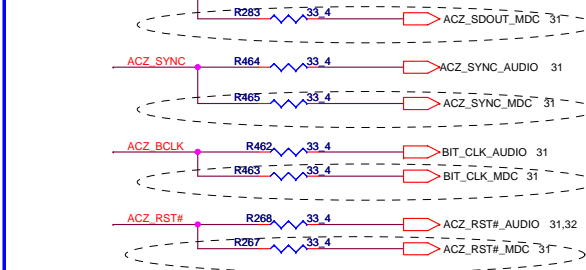
HDA

A1A: 9/6 base on Intel design guide, add it.

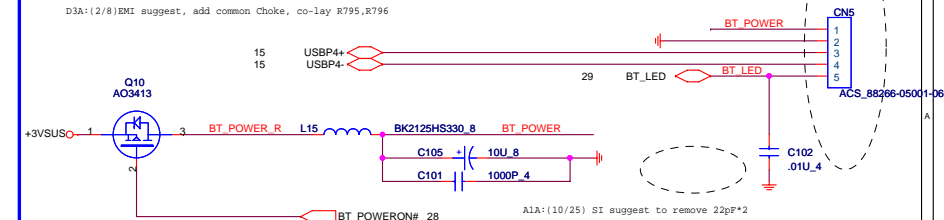
BLUETOOTH MODULE CONNECTOR

AlA: (9/25) change CONN (follow ZH3)

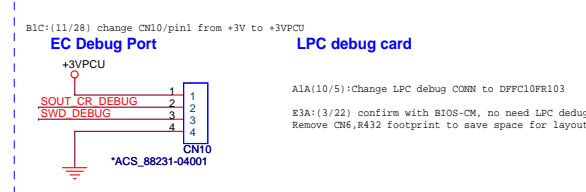
DEBUG PORTS

A1A: (10/5): Change LPC debug CONN to DFPC10FR103
E3A: (3/22) confirm with BIOS-CM, no need LPC debug CONN, Remove CM6, R432 footprint to save space for layout.

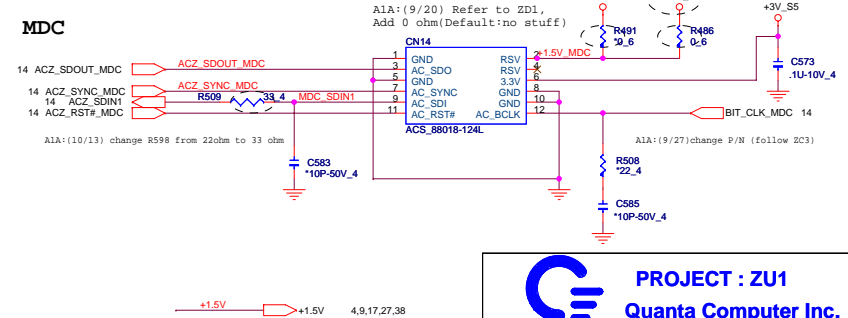
MDC

D3A:(1/21) Change CN14/pin 2 from +3v to +3v_s5.
Fix Modem wake from S3 fail issue.
