Schematics Page Index (Title / Revision / Change Date)				
Page	Title of Schematics Page		Page	Title of Schematics Page
01	Schematics Page Index		43	EC + SPI ROM
02	BLOCK DIAGRAM		44	EC (GPIO Extend)
03	SNB (DMI,PEG,FDI)		45	Debug Port
04	SNB (CLK,MISC,JTAG)		46	FAN
05	SNB (DDR3)		47	SATA HDD
06	SNB (POWER)		48	SATA ODD
07	SNB (GRAPHICS POWER)		49	Camera
08	SNB (GND)		50	Status LED
09	SNB (RESERVED)		51	USB 2.0
10	PCH (HDA,JTAG,SATA)		52	USB 3.0
11	PCH (PCI-E,SMBUS,CLK)		53	Mini-PCIE Card (WLAN)
12	PCH (DMI,FDI,PM)		54	Mini-PCIE Card (WWAN)
13	PCH (LVDS,DDI)		55	TPM
14	PCH (PCI,USB,NVRAM)		56	Bluetooth Connector
15	PCH (GPIO,VSS NCTF,RSVD)		57	G-Sensor
16	PCH (POWER) 1/2		58	H/W Thermal Protect
17	PCH (POWER) 2/2		59	MB to DB Conn.
18	PCH (VSS)		60	Power Design Diagram
19	DDRIII(SO-DIMM 0) 1/2		61	Identify IC
20	DDRIII MD 1/5		62	SYS Power (+3 3V/+5V)
21	DDRIII MD 2/5		63	VTT&PCH Power(+1 05V)
22	DDRIII MD 3/5		64	DDR3 Power(+1 5V/+0 75V)

FOXCONN		HON HAI Precision Ind. Co., Ltd.	
		CCPBG - R&D Division	
Title	Index Page		
Size	Document Number	Rev	
Custom	V030 MP MB	1.3	
Date:	Thursday, January 20, 2011	Sheet	1 of 75

Huron River Platform+ ATI Whistler/Seymour Discrete Graphic

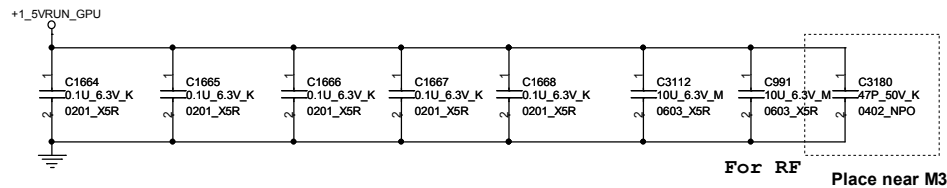
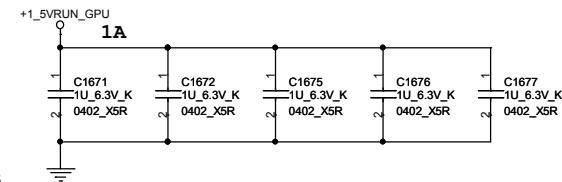
Place around the VRAM M3

PLACE 1UF CAPACITORS CLOSE TO THE MEMORY DEVICE.

PLACE 0.1UF CAPSUNDER THE MEMORY DEVICE.

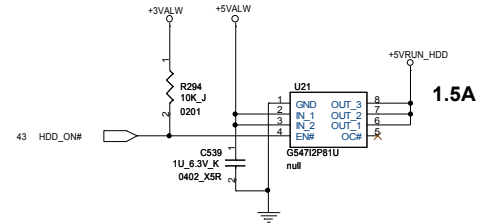
HDD Power

Change Power circuit for short test fail issue 10/14

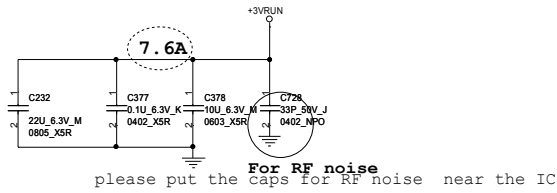
SATA HDD CONN

10/09/28 D12 change to SSM34APT (Small package, M9F0 use)

11/29
[69 -- Others power plane] Change PU3 power supply to +5VALW (Power request)
[69 -- Others power plane] Change PR44 TO 200K (Power request)
[47 -- SATA HDD] Add C232 (SSD power pk-pk ripple test fail)
[59 -- MB to DB Conn.] Add R52 (reserve for over load test fail)
[59 -- MB to DB Conn.] Change CN9 PIN 39 to +3VALW from AC_OFF_EC#(Power request)
[39 -- CRT] Add C639/C638 back
[39 -- CRT] Change R472/R471 back to 3.9K
[14 -- PCH (PCI,USB,NVRAM)] Add C826 (EMC request)
[48 -- SATA ODD] Mount D13 and change to SL22 (EMC request)
[43 -- EC + SPI ROM] R904 change to 10K follow T8 circuit solution (NPIT)
[40 -- LVDS] Change CN26 Pin 36/37/40 to LCDVCC from NC (Reserve for 15'')
[40 -- LVDS] Change CN26 Pin 34 to GND (EMI request)
[43 -- EC + SPI ROM] Reserve R145 for PECI undershoot issue

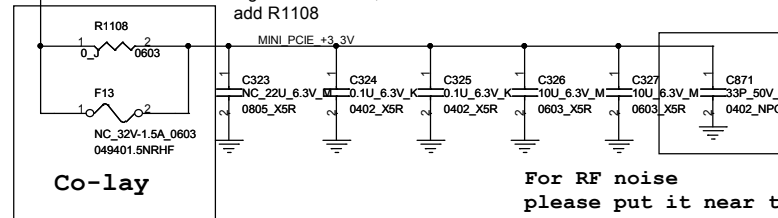
2010.1224
Due to concern of fuse voltage drop is larger than resistor, need delete F13 and add R1108

For RF noise
please put it near the connector

[59 -- MB to DB Conn.] Delete R52 (Move to DOCKING DB)
[59 -- MB to DB Conn.] Add R1101/R1102/R1103/R1104/R1105/R1106 (For over load test fail issue ,shall change to fuse)
[47 -- SATA HDD] Add R1107 (For over load test fail issue ,shall change to fuse)
[53 -- Mini-PCIE Card (WLAN)] Add R1108 (For over load test fail issue ,shall change to fuse)

[27 -- ATI VGA (I/O) 3/8] Add Q20/R6037 (+3V3_DELAY leakage issue)
[11 -- PCH (PCI-E,SMBUS,CLK)] Reserve R146 follow NPIT suggestion
[47 -- SATA HDD] Delete R1107 (Placement difficulty)
[59 -- MB to DB Conn.] R1101 co-lay with F2,R1102 co-lay with F3,R1103 co-lay with F10,R1104 co-lay with F11
[59 -- MB to DB Conn.] R1105 co-lay with F14,R1106 co-lay with F15
[53 -- Mini-PCIE Card (WLAN)] R1108 co-lay with F13
